REPORT NO. CG-D-02-79

IDENTIFICATION AND EVALUATION OF
DEEPWATER PORT HOSE INSPECTION METHODS

U.S. DEPARTMENT OF TRANSPORTATION
RESEARCH AND SPECIAL PROGRAMS ADMINISTRATION
Transportation Systems Center
Cambridge MA 02142

FINAL REPORT

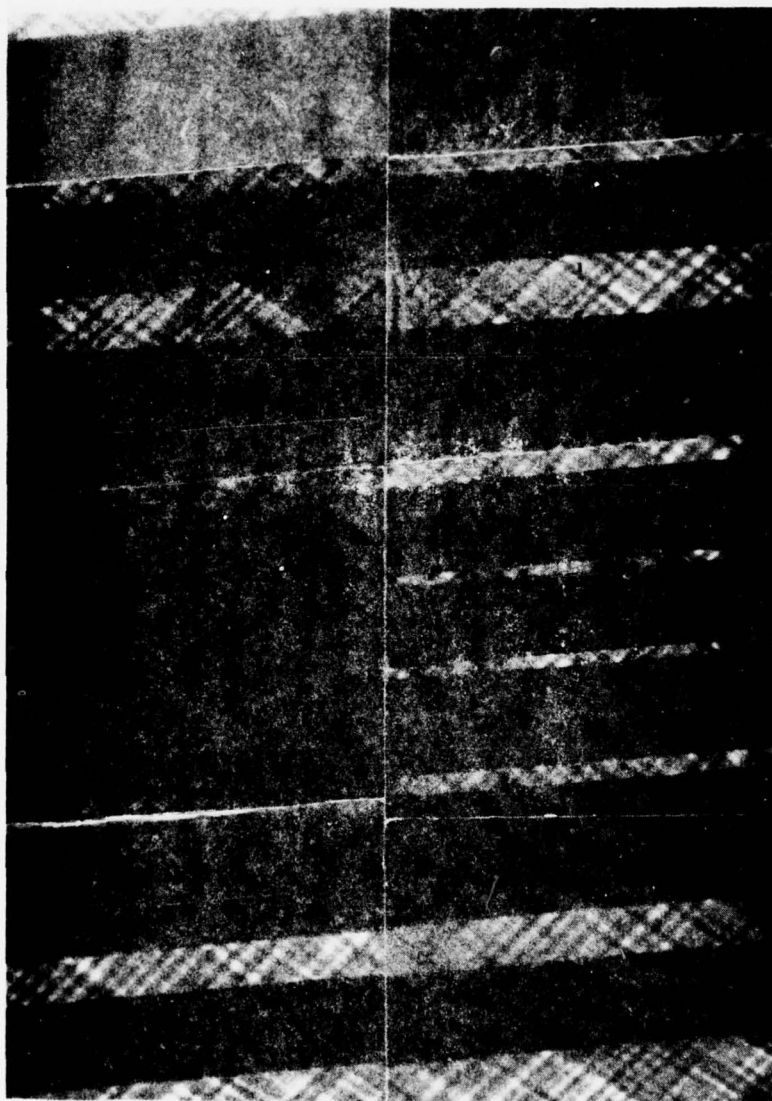
FIGURE 7-1. X-RAY OF HOSE SECTION (COMPOSITE)

Figure 7-1 is an x-ray composite of a section of the 24 inch hose used in this work. It was found that a power level of 70 KV was adequate to penetrate the hose material. In this particular hose, there were two helical wire reinforcements - an inner and outer helix - the inner helix having a bend radius about 1 inch less than that of the outer helix. It can be seen in the figure that the two helices appear to have different wire diameters. The two wires were in fact the same diameter, and the apparent difference is due to the fact that the x-ray source was, in this application, essentially a point source. This resulted in a cross-sectional projection of the wires on the film with dimensions dependent upon the distances among wire, source, and film. The wire of apparent smaller diameter is that nearest the film.

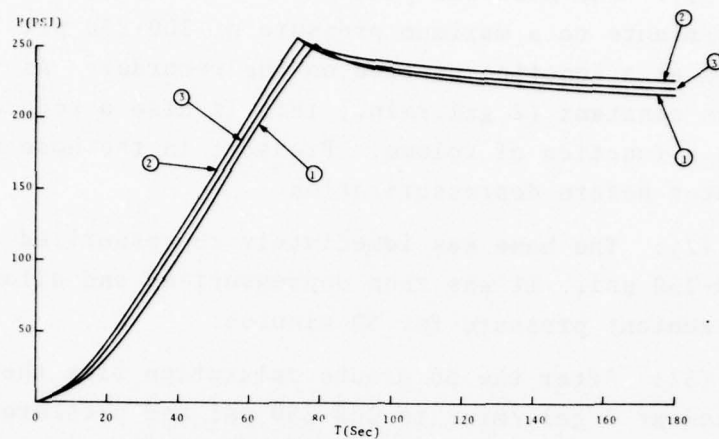
FIGURE 7-4a. DOCK HOSE PRESSURE-VOLUME DATA (HOSE NO. 1)

Figures 7-4a, 7-4b, and 7-4c are pressure-volume relationships of the three hoses which were pressurized in the manner described above. Figure 7-4a (hose #1) is data from the new hose. From Cycle (1) to Cycle (2) a hysteresis effect is present while recovery (after "relaxation") is noted in Cycle (3).

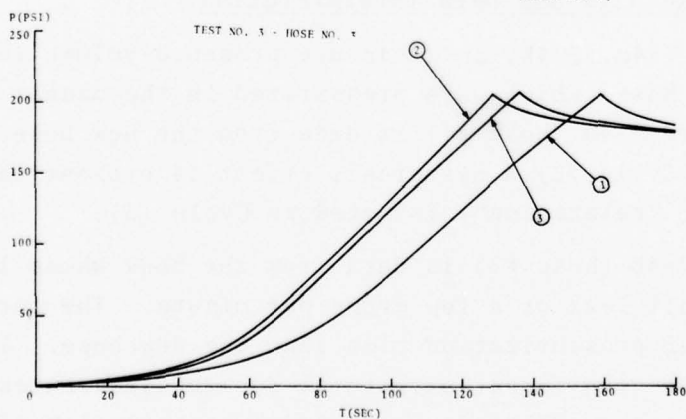
FIGURE 7-4c. DOCK HOSE PRESSURE-VOLUME DATA (HOSE NO. 3)

Figure 7-4c (hose #3) is data from the hose that had been subjected to excessive tensile stress. From cycle (1) to cycle (2) it can be seen that substantial hysteresis effects are present while some recovery is noted in cycle (3). Although this hose also had a steel helix-reinforcement, it was found to be excessively compliant as can be seen from the curves.

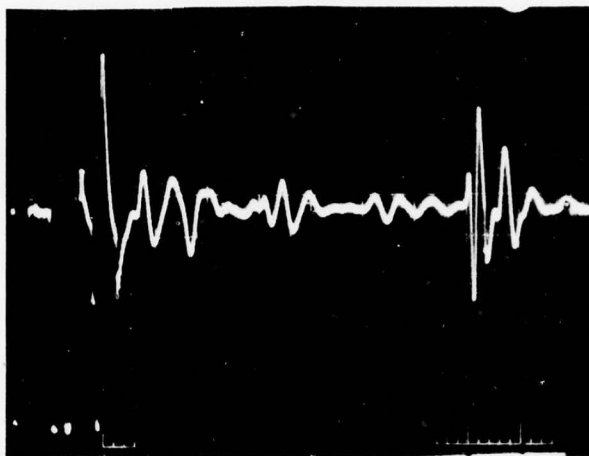
FIGURE 7-7. ULTRASONIC SCAN OF INTACT HOSE

Figures 7-7, and 7-8, show the resulting traces, at well-bonded and separated spots respectively, seen when the transducer and Plexiglas delay buffer assembly is pressed against the liner. A delayed sweep has been used to eliminate the round-trip travel time in the Plexiglas buffer, so that the first interface reflection, i.e., (the first echo from the back face of the Plexiglas) appears at the left edge of the screen. Figure 7-7 is an image of the display when scanning a section of hose having its liner tightly bonded to the hose body. Figure 7-8 is a trace showing a reflection from a separation between the liner and the hose body. It is apparent that ultrasonic detection of liner separation in deepwater port hose is clearly feasible using techniques well within the state-of-the-art.

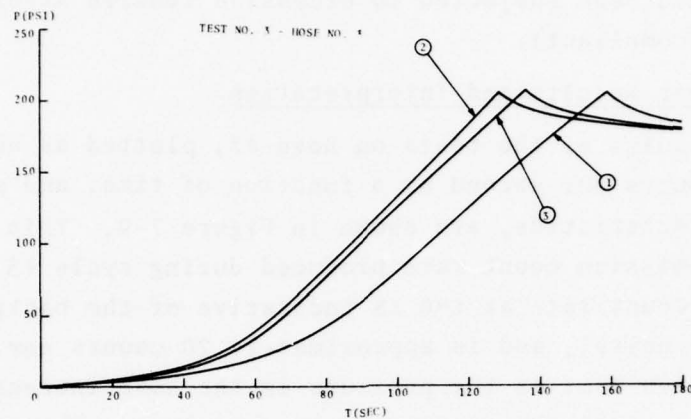
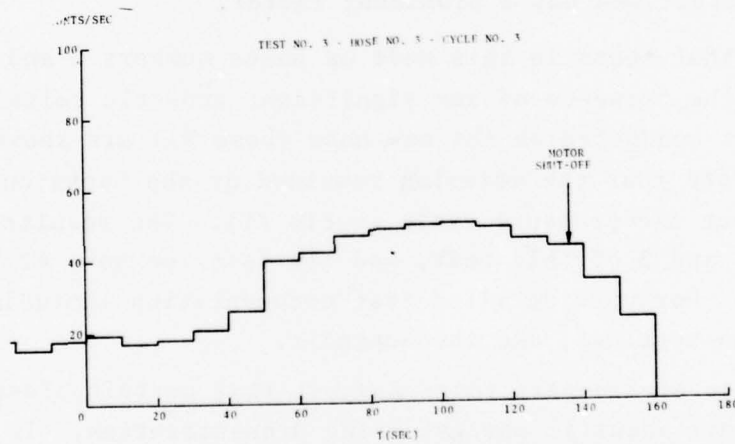
FIGURE 7-9. ACOUSTIC EMISSION AND PRESSURE VOLUME DATA (HOSE #3)

The results of the tests on hose #3, plotted as acoustic emission counts per second as a function of time, and pressure-volume characteristics, are shown in Figure 7-9. This figure shows the emission count rate produced during cycle #3 of this test. The count rate at $t=0$ is indicative of the background noise level (pump noise), and is approximately 20 counts per second. It can be seen that as the pressure in the hose increased to about 130 psi, the count rate increased to a maximum. The rate declined slightly thereafter until the motor was shut off at the maximum pressure. The rate then fell off sharply and went to zero at 160 seconds. It should be noted that the hose continued to emit even after the motor was shut off and the pressure was maintained. As this was the third cycle of the test, it is apparent that the Kaiser effect was not a prominent factor.

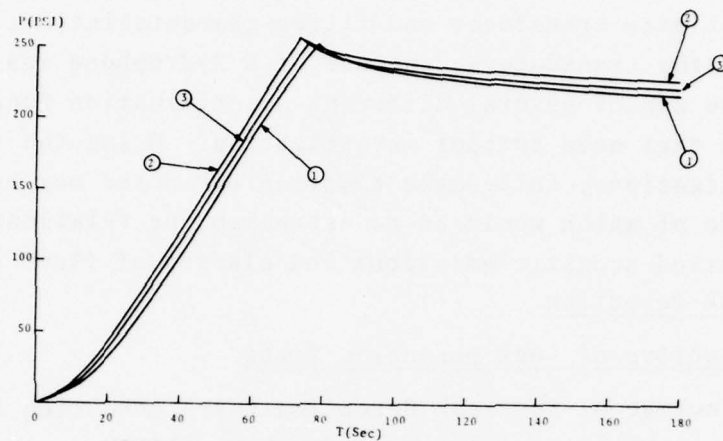
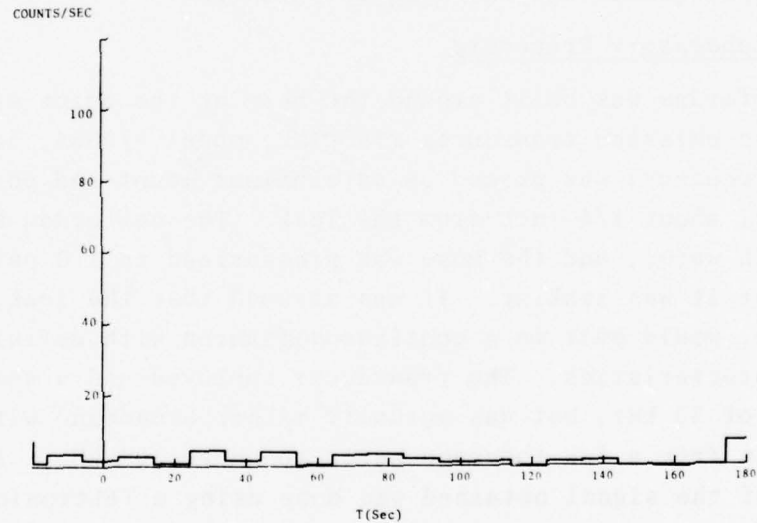
FIGURE 7-10. ACOUSTIC EMISSION AND PRESSURE VOLUME DATA (HOSE #1)

Further tests in this mode on hoses numbers 1 and 2 failed to show the presence of any significant acoustic emissions. Results of a test conducted on the new hose (hose #1) are shown in Figure 7-10. Note that the emission remained at the background level throughout the pressure cycle (cycle #1). The results for cycles numbers 2 and 3 of this test, and the tests on hose #2 were similar. For more detailed test documentation including instrumentation settings, see the Appendix.

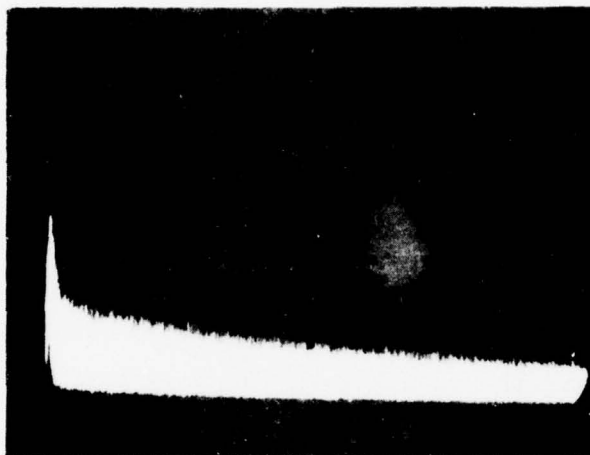
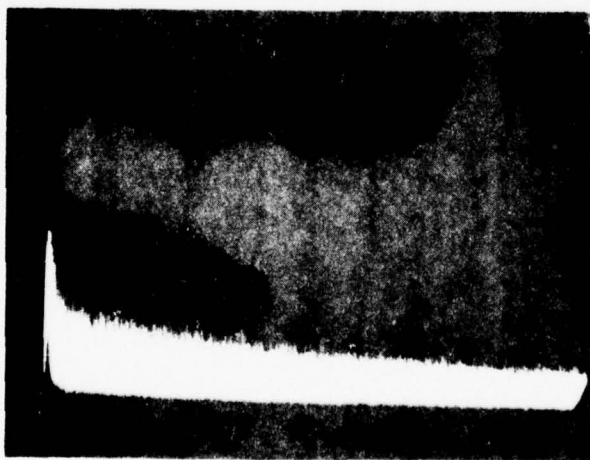
The signal frequency spectrum from 0-100 kHz obtained with the hose at ambient pressure is shown in Figure 7-11a. It is nothing more than a relative measure of system noise. The spike at the far left is a spurious dc signal with no physical meaning. The hose was then pressurized to 170 psi to assure a leak, and the spectrum from 0-100 kHz was again recorded. This is shown in Figure 7-11b; and as can be seen, there is no significant difference between this recording and the one obtained at ambient pressure.

FIGURE 7-11a. ACOUSTIC EMISSION SPECTRUM FROM 0 - 100 kHz
HOSE #2 - AT AMBIENT PRESSURE

FIGURE 7-11b. ACOUSTIC EMISSION SPECTRUM FROM 0 - 100 kHz
HOSE #2 - AT 170 psi

It is recommended that the same experiment (which takes less than a day to perform) be carried out with a low frequency hydrophone. Leaks of various sizes and types (induced in the laboratory) should also be investigated to determine the limitations of the measurement equipment in this application.

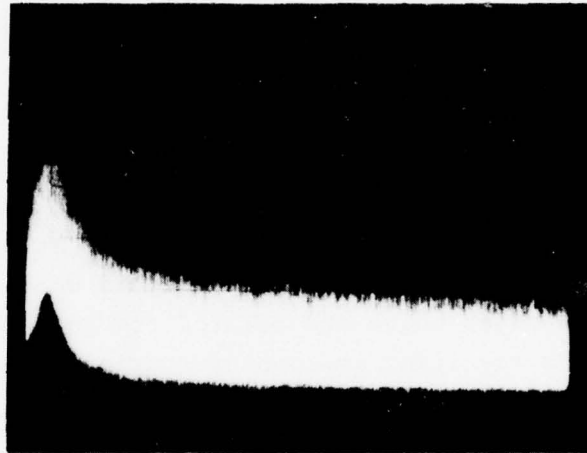
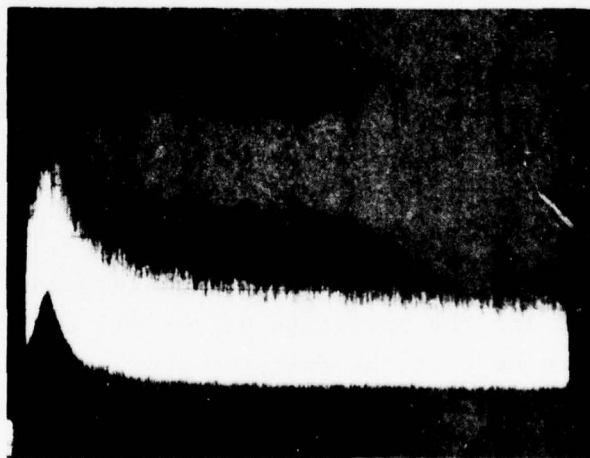
To examine the lower frequencies in more detail, tests were performed again, this time recording spectral information from 0-10 kHz. The result with the hose at ambient pressure is shown in Figure 7-12a, and the result with the hose at 170 psi is shown in Figure 7-12b. Again, there is no discernible difference between these spectral measurements. The whole spectrum was also examined in 1000 Hz increments from 0-100 kHz; and again, no differences could be detected between the spectral content when the hose was at ambient pressure and when it was at 170 psi.

FIGURE 7-12a. ACOUSTIC EMISSION SPECTRUM
FROM 0 - 10 kHz HOSE #2 - AT AMBIENT PRESSURE

FIGURE 7-12b. ACOUSTIC EMISSION SPECTRUM
FROM 0 - 10 kHz HOSE #2 - AT 170 psi

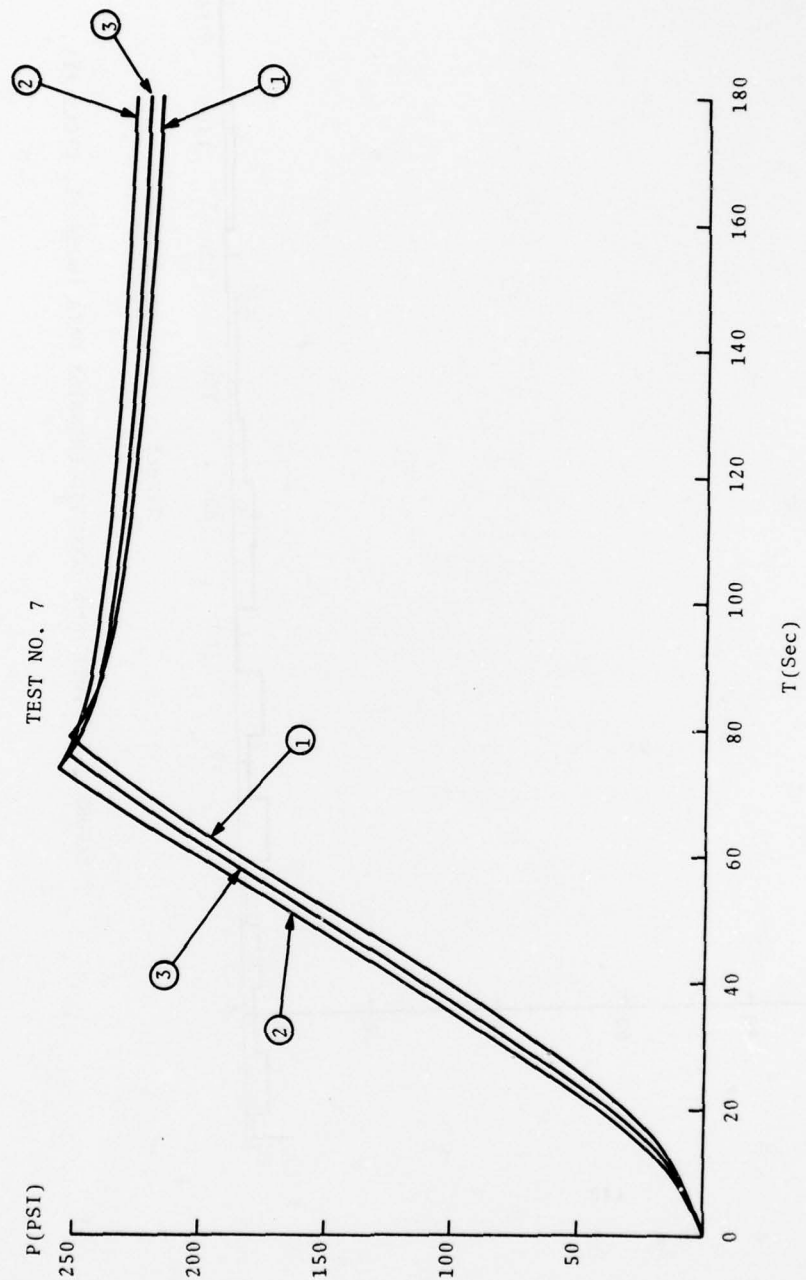
FIGURE A-6. DOCK HOSE PRESSURE-VOLUME DATA (HOSE #1)

Only a slight hysteresis effect was noted in the pressure volume traces with some recovery (attached). Both channels of acoustic emission data and pressure were recorded on magnetic tape -- tape speed, 30 ips BW, 100Hz to 150kHz.
